# MONUMENT RECORD

Corner ID: **BeBI\_K05**

## Quarter Corner

Sections 4 & 9- T10N-R02W, 2nd P.M.  
Bean Blossom Township, Monroe County, Indiana

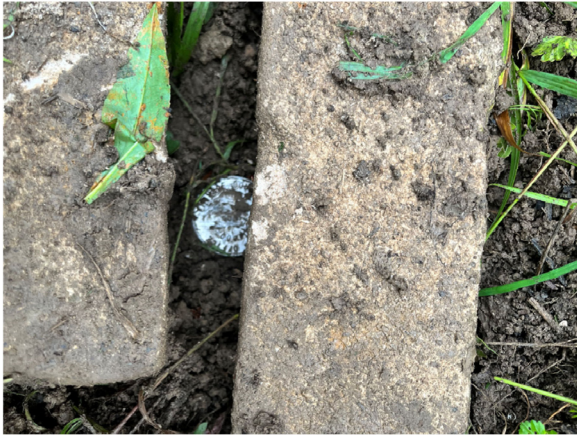
Photo Orientation & Description: From above

*Date of Field work/Search:* 02/13/24 & 05/09/24 *By:* MES/JMG *Monument Found:* Broken stone and bent rebar *BTs or Reference Objects Found:* No, but references established *Project #:* 24-001 *Field Book:* 56, pages 1,38&39 *Notes:*

We pulled the severely bent rebar found between the 2 stone pieces and set a straight one with aluminum cap in its place. GPS coordinates were established on the rebar. A survey marker sign was nailed to a power pole, 5' above ground, facing the monument. We located 2 power pole legs for visual references and a rebar lite and a rebar, within view of the monument, that could be used to reestablish its location should it become obliterated.

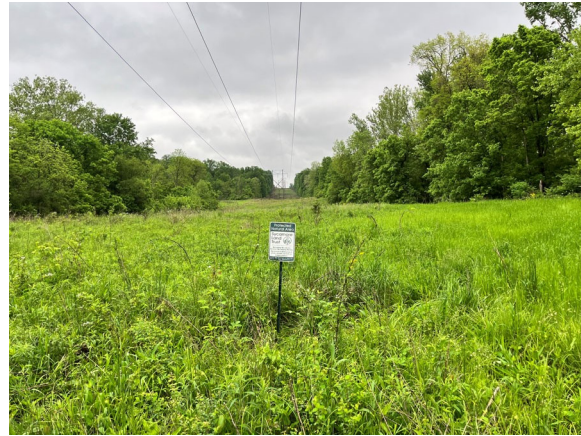
Photo Orientation & Description: From West looking East
